## **Architectural Survey of Seven Wyoming Army National Guard Armories, 1961–1974**

**Volume 1 of 2**

Final Report

Under Project No. 455557, “Wyoming Armories Historical Context and Building  
Evaluation”

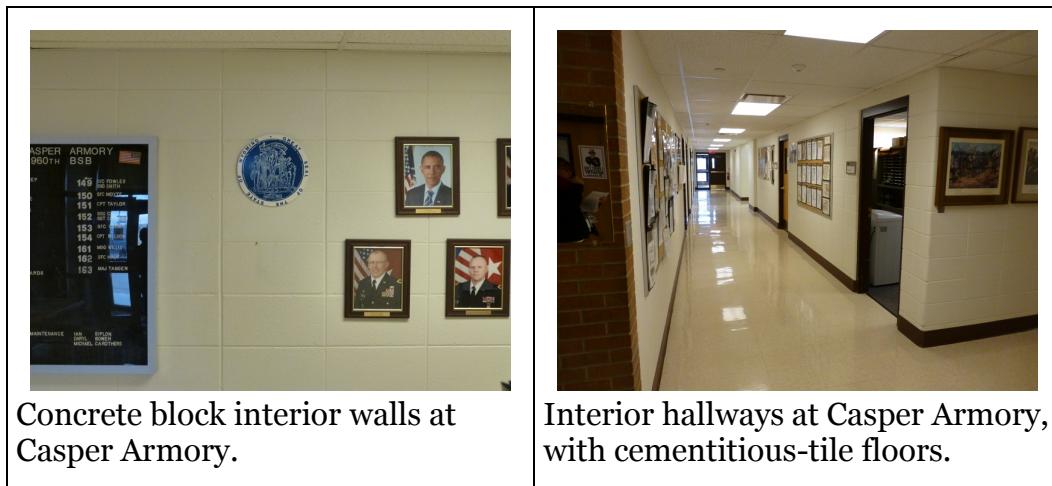
Figure 50. Examples of key design features for the Casper Armory (ERDC-CERL, 2015).

<p>Brick veneer at Casper Armory.</p>	 <p>Combination of one-story and double-height drill-hall space at Casper Armory, with a gable roof over double-height space and shed roof over one-story space.</p>
 <p>Repetitive window pattern at Casper Armory.</p>	 <p>Open double-height drill-hall space at Casper Armory, with concrete floors, concrete block walls, and exposed steel structure.</p>

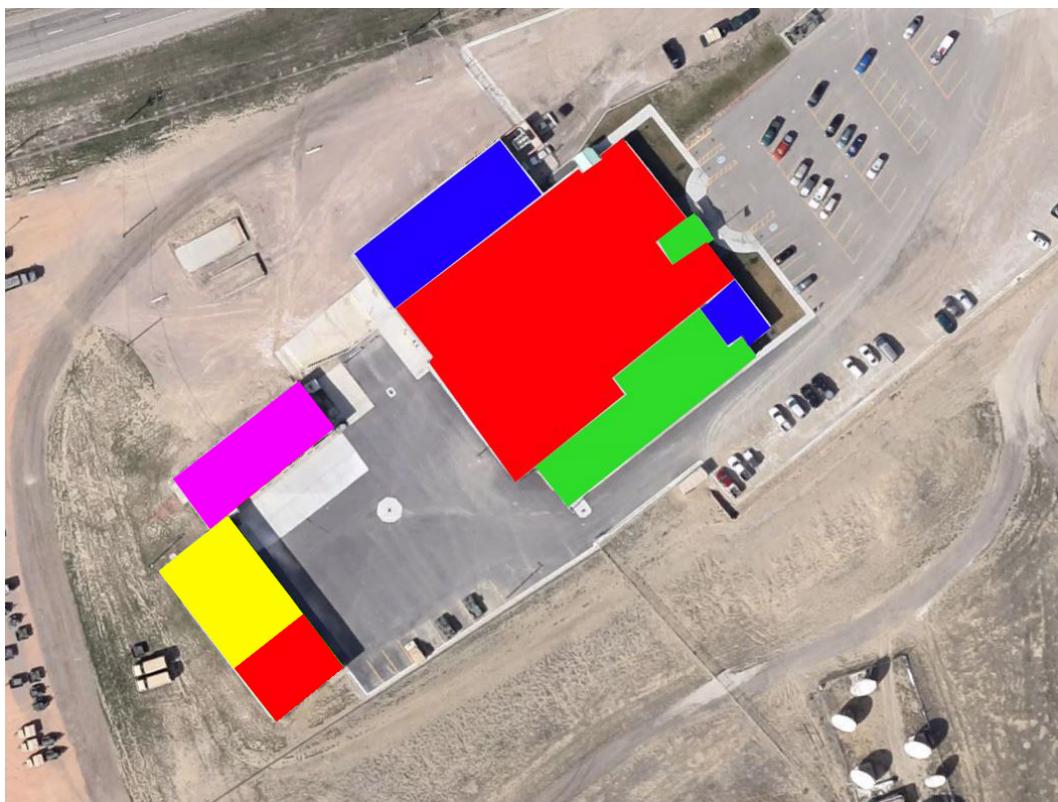
Figure 52. Aerial of Casper Armory and first FMS (in red), with additions marked in blue, green, yellow, and magenta by ERDC-CERL (google.com, 2016).

It is the recommendation of this report that the WYARNG Casper Armory building and its original FMS are **NOT ELIGIBLE** to the NRHP due to their loss of integrity by the large additions on the north, west, and south of the armory; the addition of the green metal roof over the one-story sections of the armory; the addition of the synthetic roof over the armory's drill hall; and the addition to the original three bay FMS and the construction of a second FMS.

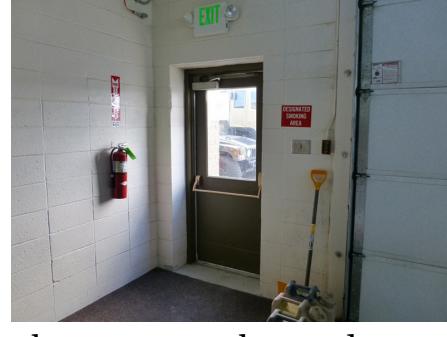
**Figure 61. Examples of modifications to key design features for the Evanston Armory (ERDC-CERL, 2015).**

- replacement vinyl windows
- metal entry doors (replaced)
- locker rooms and latrines (modified)
- firing range removed and now used for storage (interior)

<p>Replacement vinyl windows at Evanston Armory.</p>	<p>Replacement metal entry doors at Evanston Armory.</p>

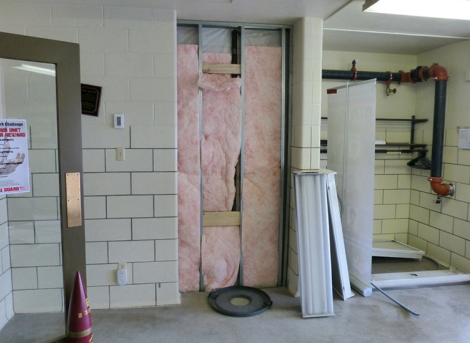
Figure 65. Examples of modifications to key design features for the Lander Armory (ERDC-CERL, 2015).

- replacement windows
- interior layout changes and renovations
- firing range removed and now used for storage (interior)

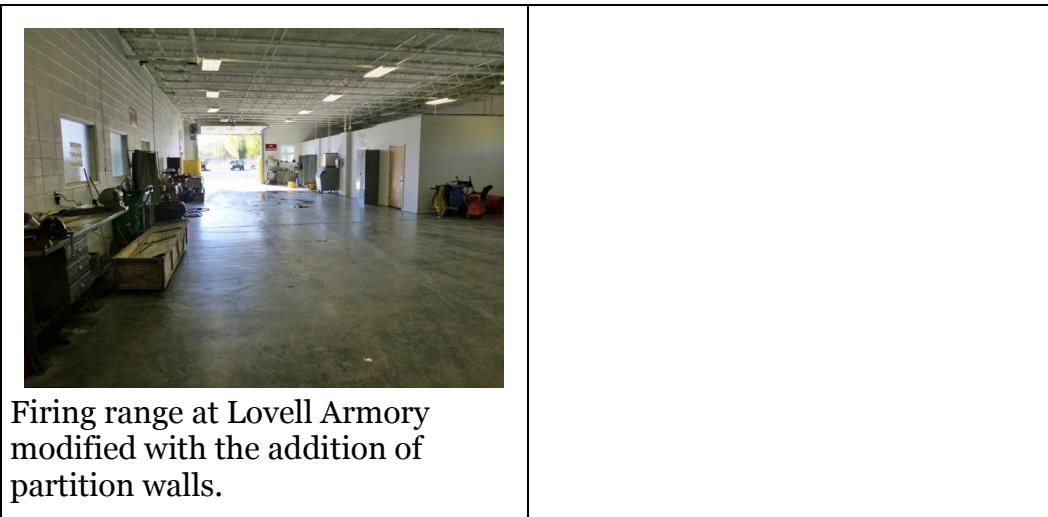
Figure 72. Examples of the modifications to the key design features for the Lovell Armory (ERDC-CERL, 2015).

<p>Replacement vinyl window combination (original paired four-pane awning/hopper style windows) at Lovell Armory.</p>	 <p>Replacement small square single-pane awning-style windows (original were two-pane hopper-style windows) at Lovell Armory.</p>
 <p>Paired, single-pane fixed or awning-style windows (original paired two-pane hopper style clerestory windows) at Lovell Armory.</p>	 <p>Former locker rooms at Lovell Armory (modified into a multipurpose room).</p>

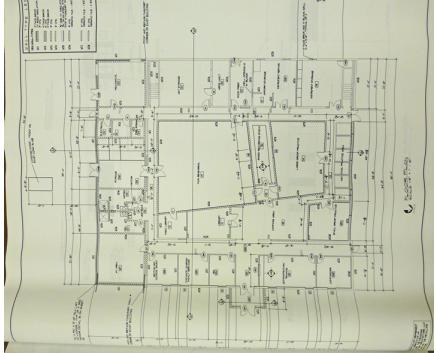
- replacement windows

<p>East elevation of the south addition (left side in photo) showing the difference in exterior cladding material at Wheatland Armory.</p>	<p>Interior layout changes for Wheatland Armory.</p>
